NAVAL POSTGRADUATE SCHOOL MONTEREY CA
A-10/GAU-8 LOW ANGLE FIRINGS VERSUS SIMULATED SOVIET TANK BATTAL--ETC(U)
AUG 80 R H STOLFI, R R MCEACHIN

A-10/GAU-8 LOW ANGLE FIRINGS VERSUS
SIMULATED SOVIET TANK BATTALION
(HONEYWELL LOT NUMBER 0L78D043-016)
(ARRAY 3)
2 FEBRUARY 1979.

AUGUST 1980

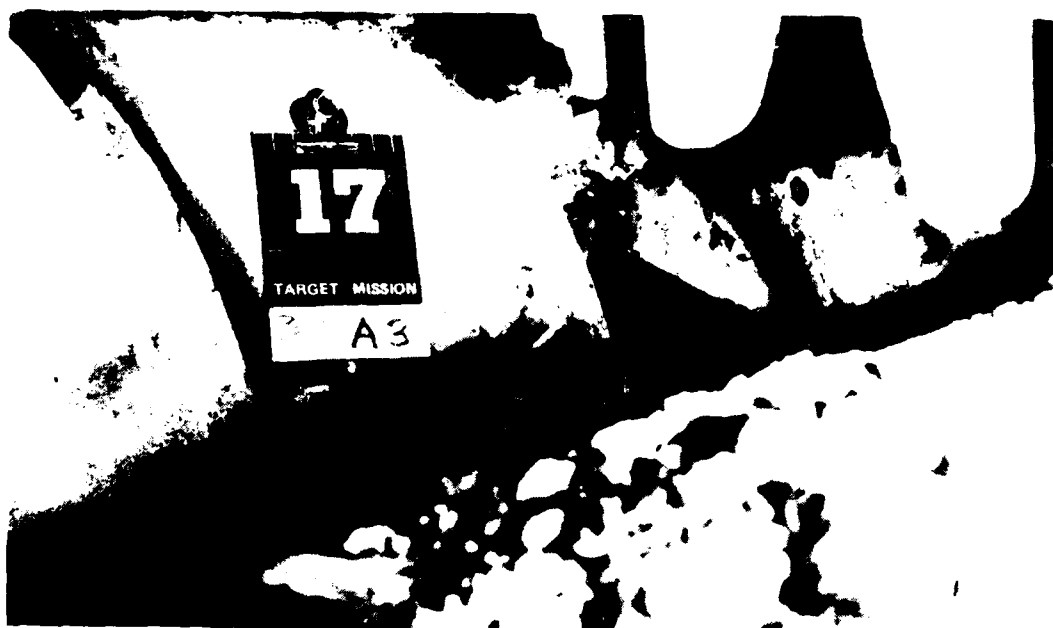
FIGURE 63. Impact Seventeen, Target 32, Perforation of the hull Armor and Penetration into the Left Fuel Tank.

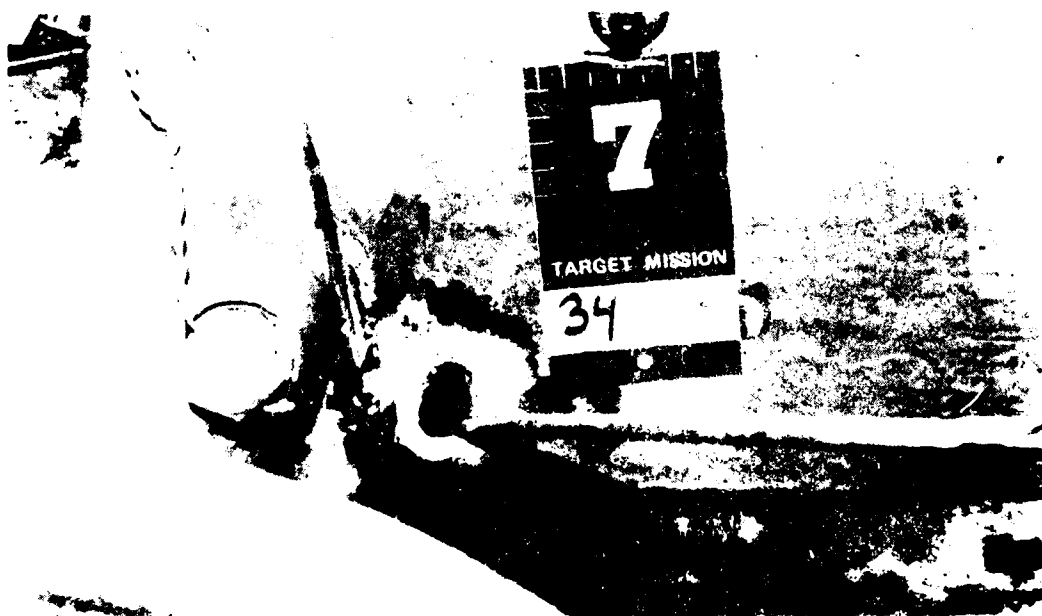
FIGURE 71. Impact Seven, Target 34, Penetration of the Left Hull Armor in the Stowage Area.

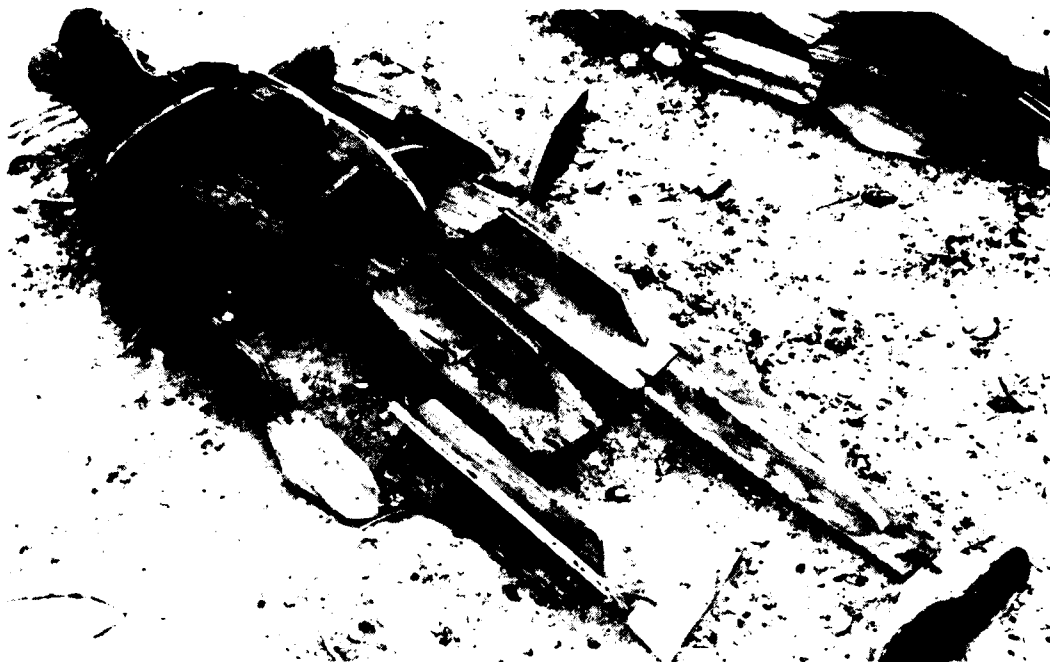
FIGURE 73. Commander Manikin, Target 35, Showing Damage from Perforations into the Fighting Compartment.

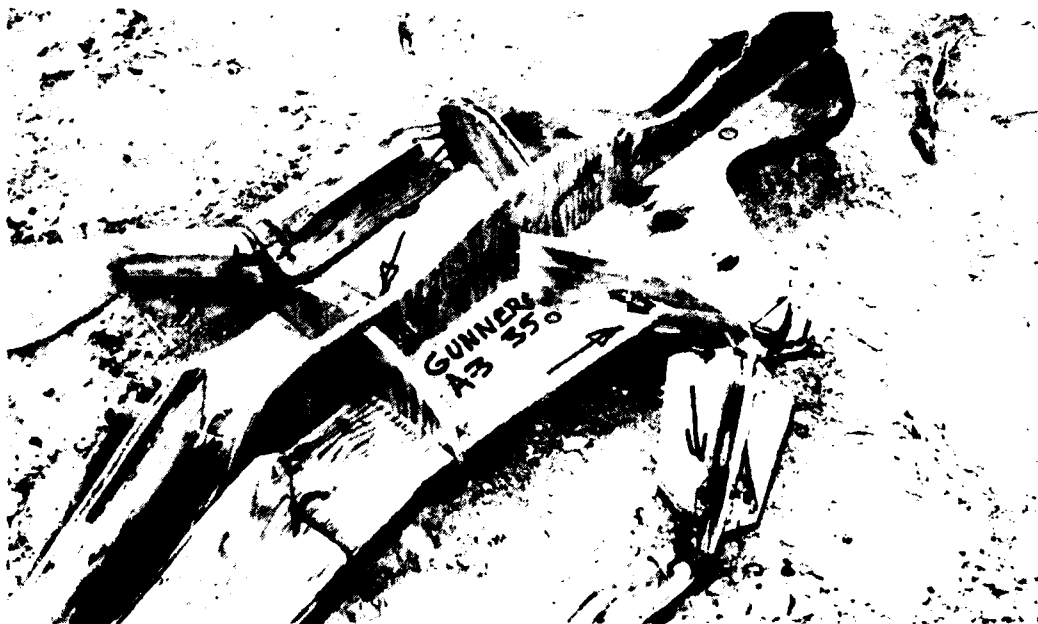
FIGURE 74. Gunner Manikin, Target 35 Showing Damage from Perforations into the Fighting Compartment.

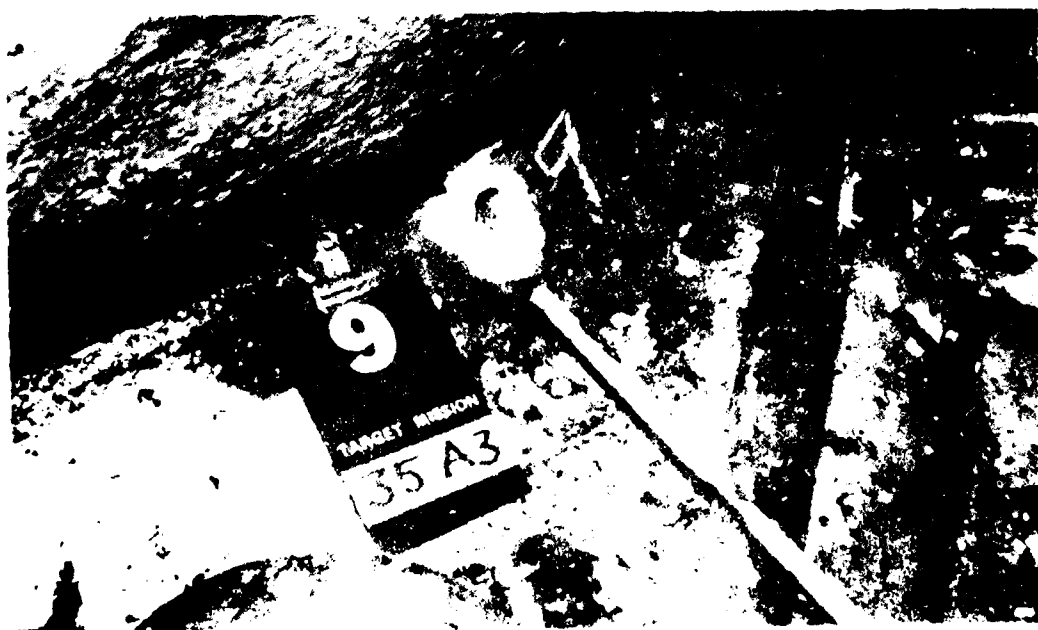
FIGURE 76. Impact Area, Target 35, with Perforation of Top of Loader which hit the target.

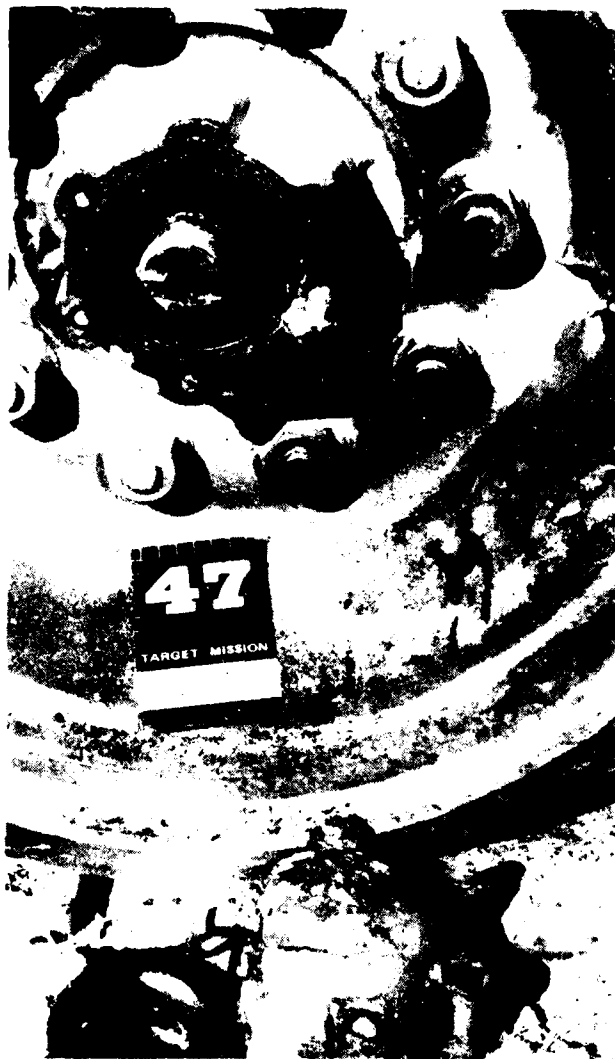
FIGURE 80. Impact Forty-Seven, Target 36, which Destroyed the Left #5 Roadwheel Hub Bearings.

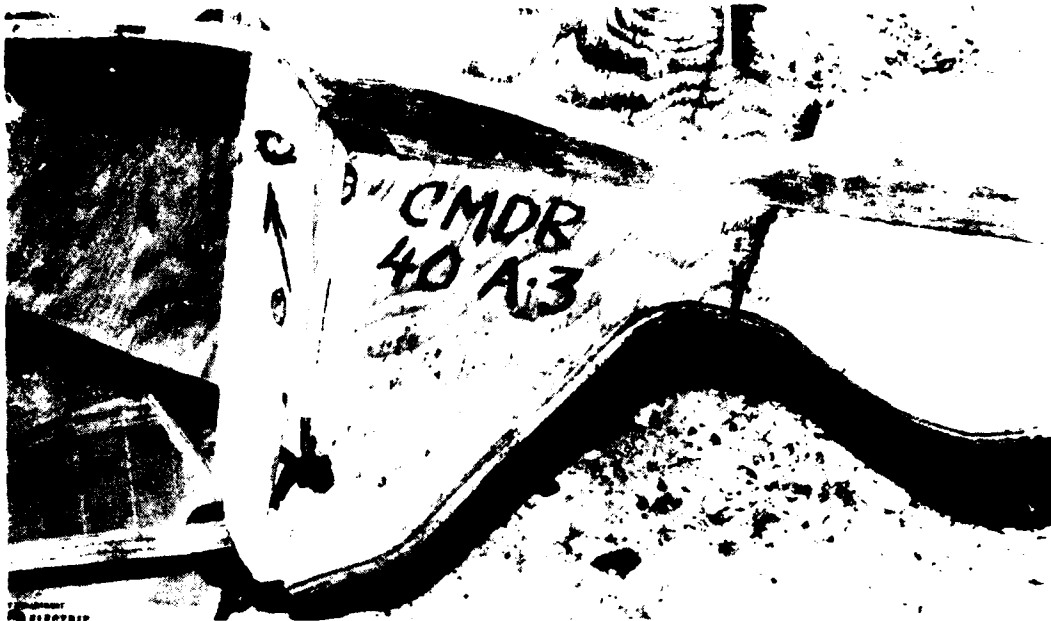
- b. F-Kill: Impact 15, shown in Figure 103, perforated the left side of the commander's cupola and made him a casualty (Figure 104). Impact 3, shown in Figure 105, jammed the turret so that it could not be traversed. Impacts 12 and 13, which destroyed the gunner's periscope head, contributed to the kill.

FIGURE 104. Commander Manikin, Target 40, Showing Damage from Impact 15.
